TRADITIONAL GENIUS AND EARTHQUAKES

BY PIYOOSH RAUTELA

Traditional building techniques have always existed in regions vulnerable to earthquakes. Unfortunately, aspirations to modernity have tended to bury these norms, resulting in heavy casualties in recent times.

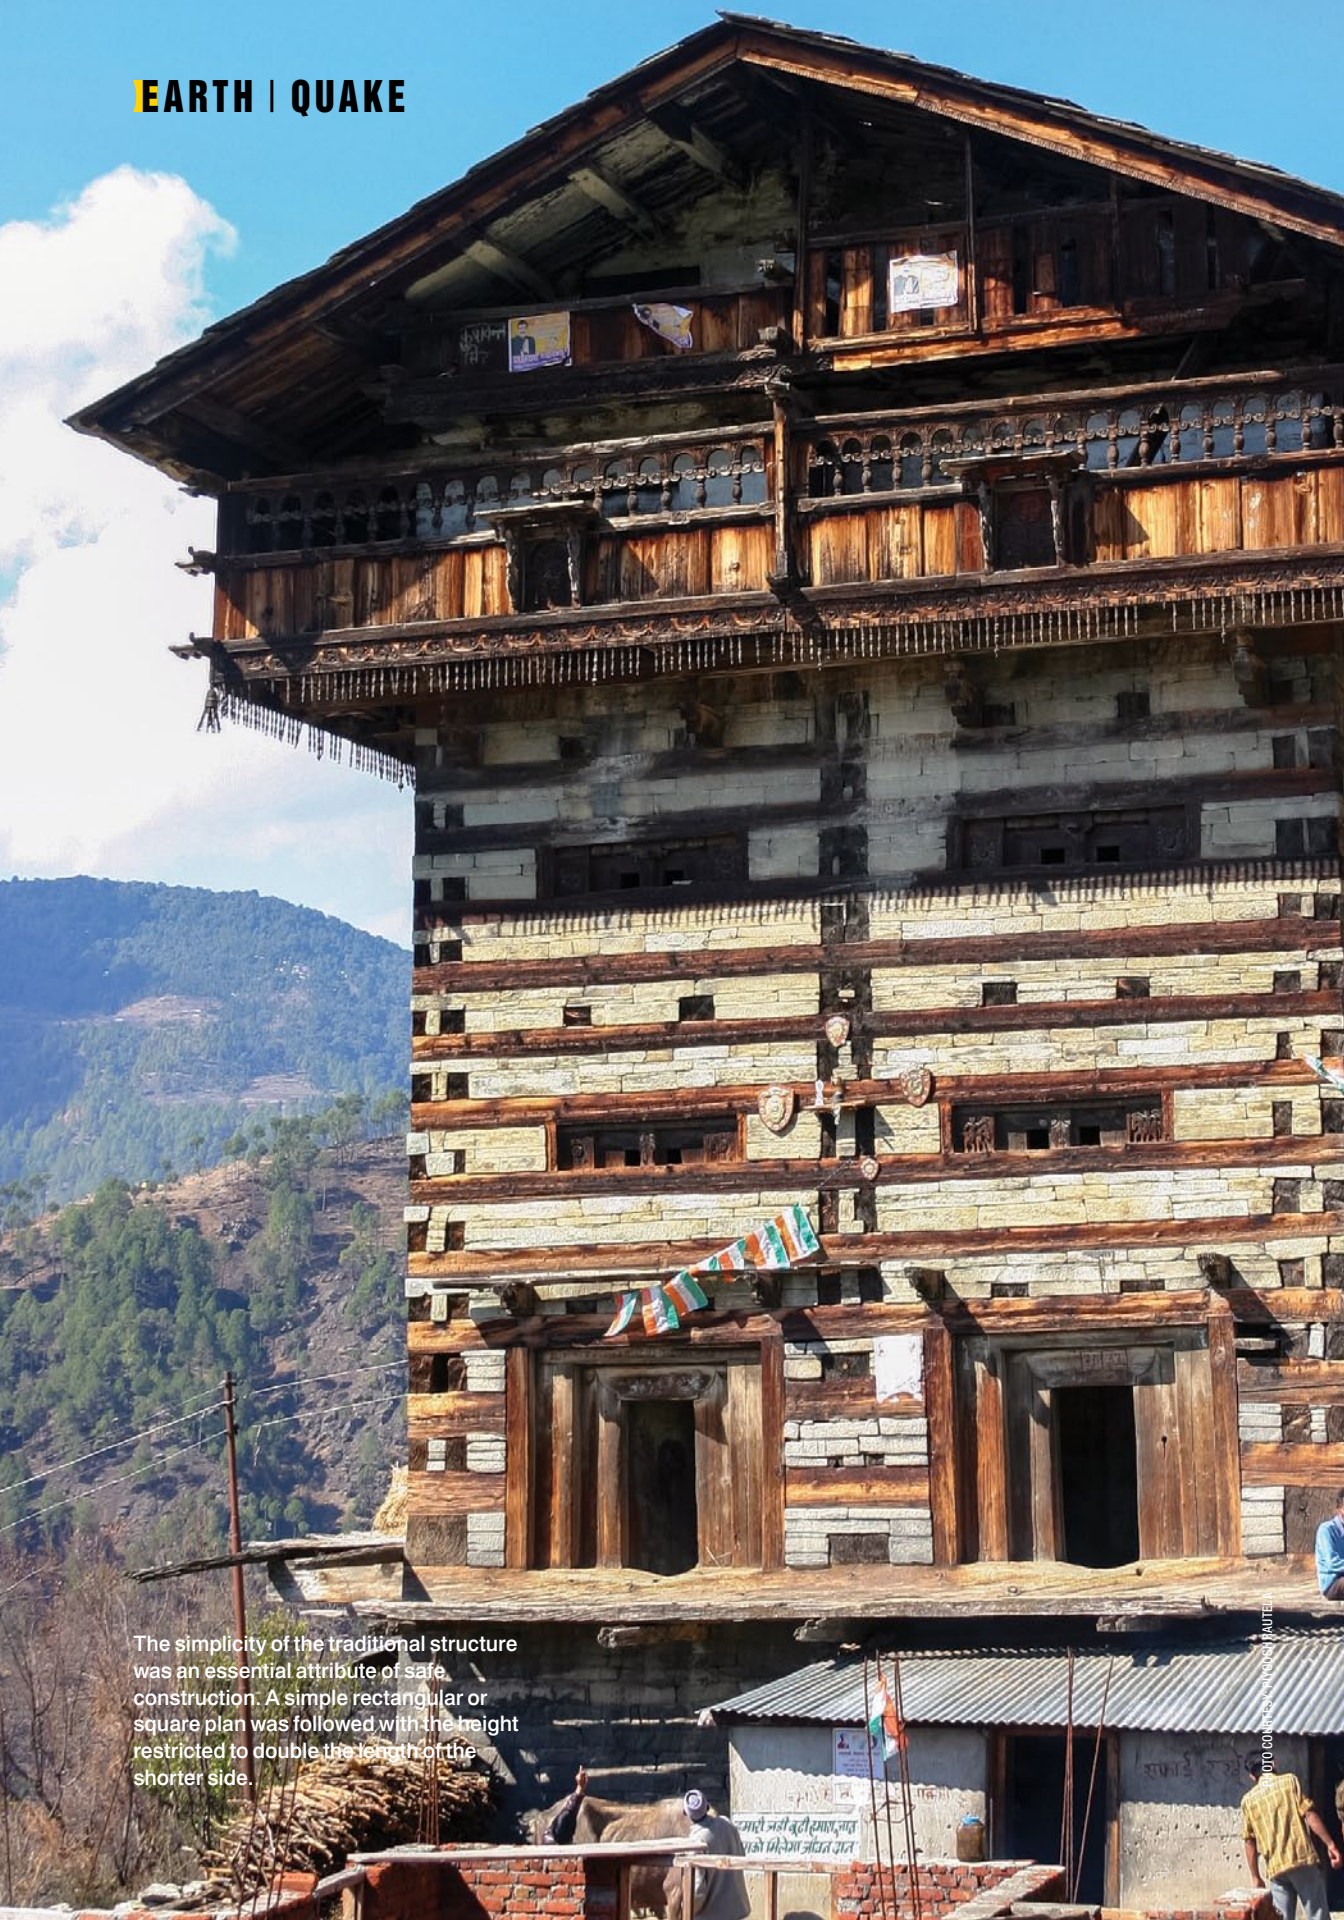
The simplicity of the traditional structure was an essential attribute of safe construction. A simple rectangular or square plan was followed with the height restricted to double the length of the shorter side.

Simplicity: The simplicity of the structure was an essential attribute of safe construction. A simple rectangular or square plan was followed with the length of the sides varying between 4 and 8 m. The ratio of the two sides of the structure varied between 1.1 and 1.4 and the height was restricted to double the length of the shorter side.

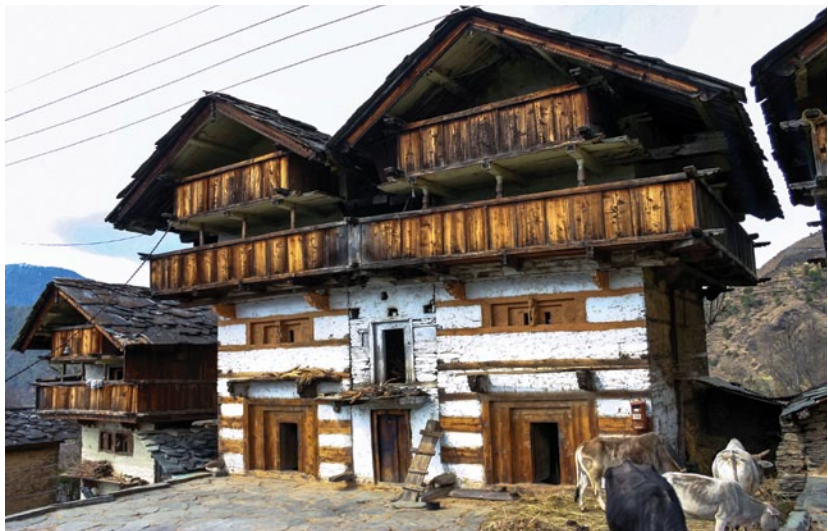
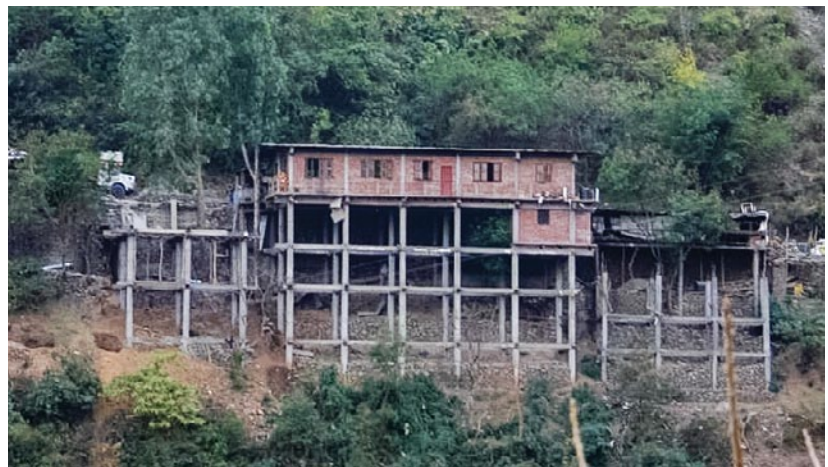
As opposed to traditional structures, a network of ill-reinforced and unplanned beams and columns that defy the slope of hills of Uttarakhand are in place today. Heavy structures on steep hill slopes are the bane of Devprayag, Karnaprayag, Almora, Rudraprayag and Bhatwari.

the region in recent times has found many locals keen to cash in on the business boom. This has, in turn, seen many put up guest houses and hotels to make the most of this opportunity. A network of ill-reinforced and unplanned beams and columns that defy the slope of hills of Uttarakhand are in place today. Even riverbeds have been encroached upon to make a neat profit out of tourism. Heavy structures sited over elongated columns and multiple storeys on steep hill slopes are the bane of Devprayag, Karnaprayag, Almora, Rudraprayag and Bhatwari. Except for a few urban areas, building codes are non-existent. Even where well-defined building codes are in place, enforcement is weak and defaulters get their constructions regularised by paying penalties if reprimanded.
